Somerville High School

Somerville Historic Commission

Existing High School:

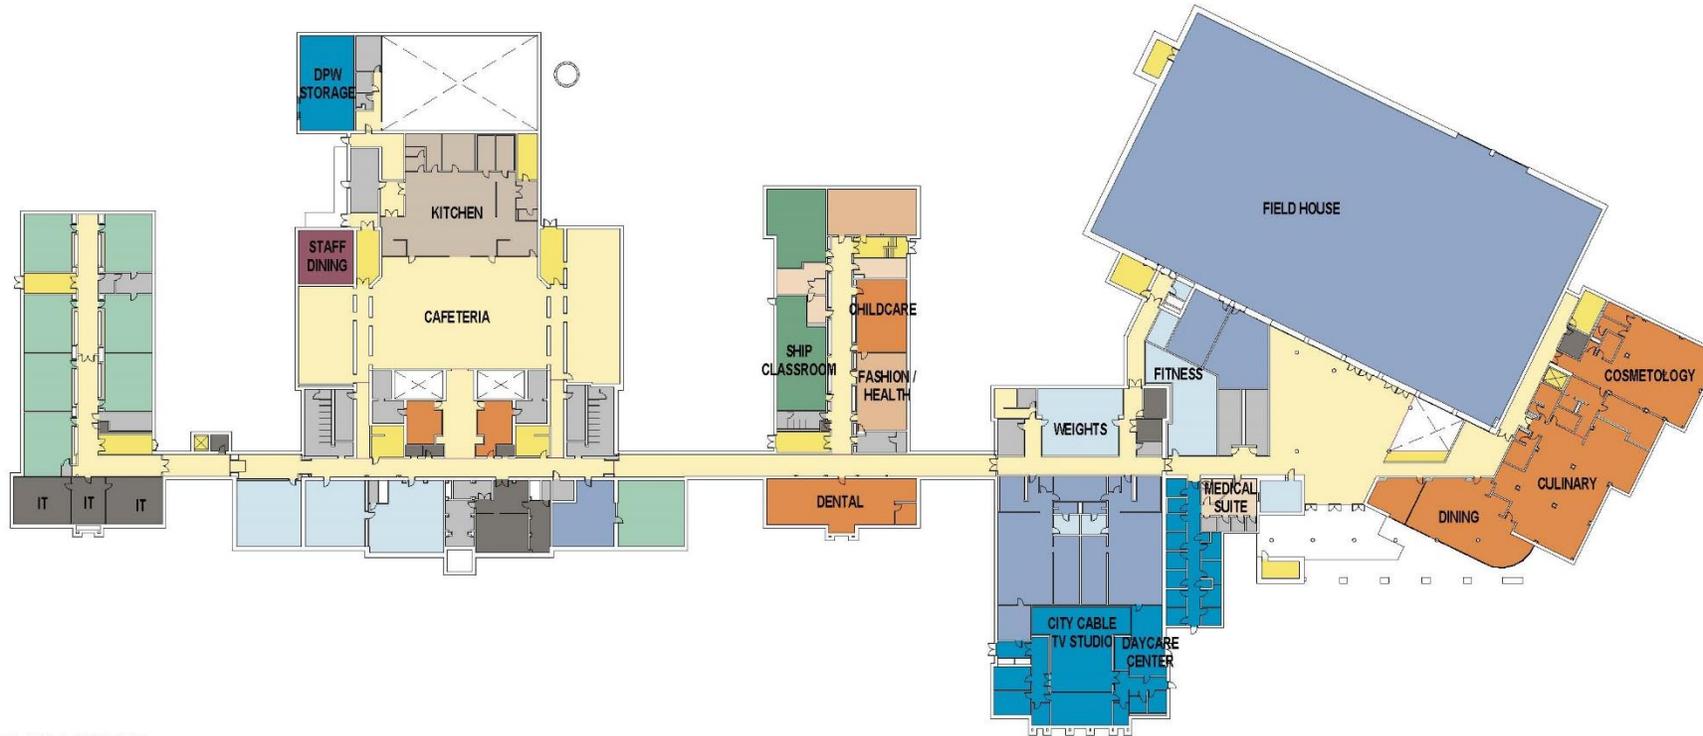
Existing High School – 1st Floor Program Plan

Somerville High School GSF	
LEVEL	AREA
SHOP LEVEL	45900 SF
1ST FLOOR	125420 SF
2ND FLOOR	89950 SF
3RD FLOOR	64080 SF
4TH FLOOR	44220 SF
TOTAL GSF:	369570 SF

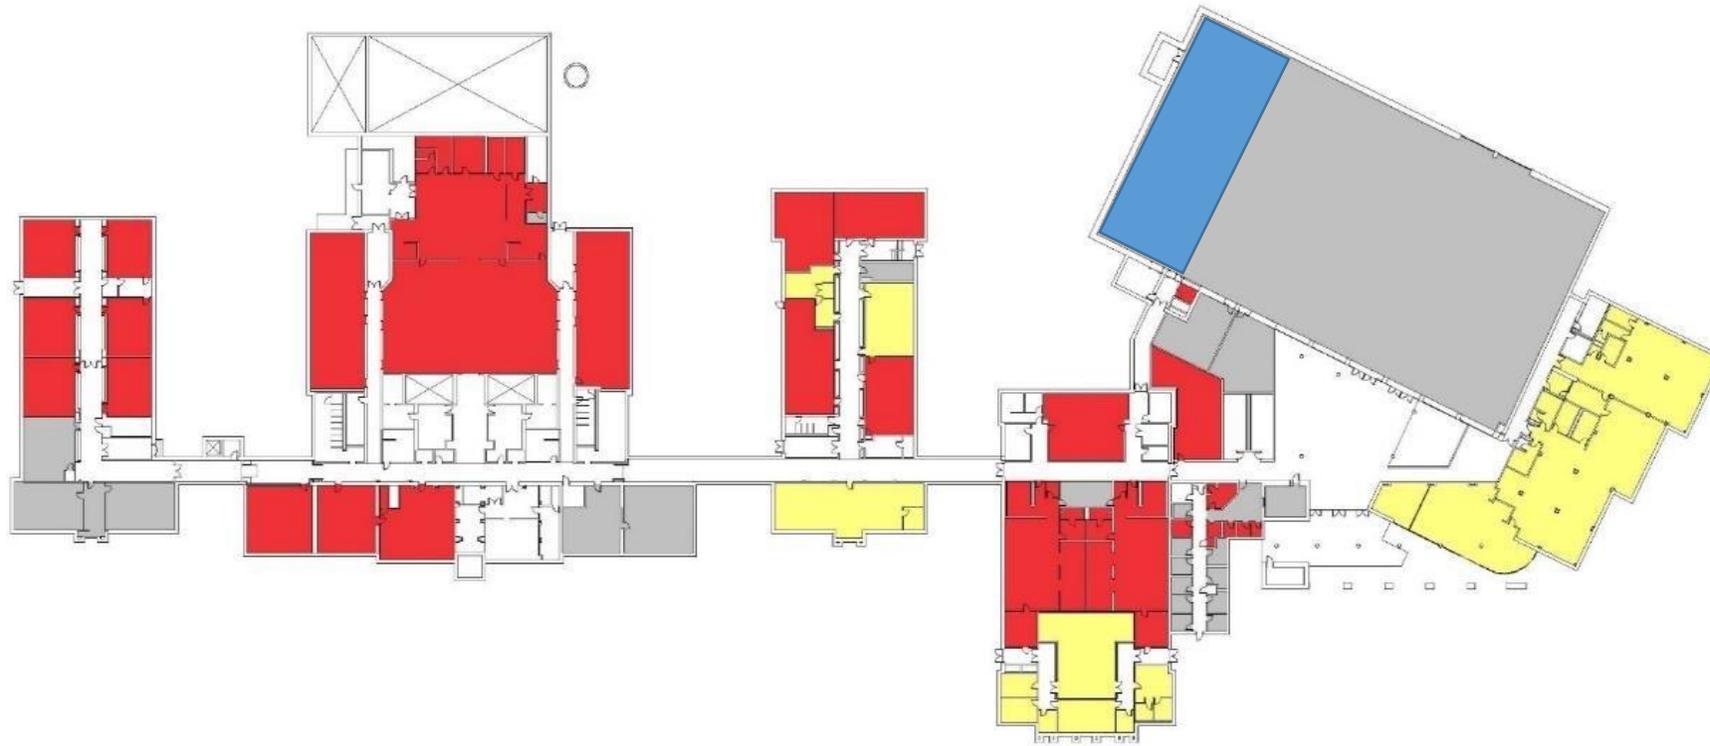
Existing High School – MSBA Program Deficiency Plan

- Grey Square Footage Meets MSBA Requirements
- Yellow Not Within a Typical MSBA High School Program
- Red 10% or More < MSBA Space Standards
- Blue Not Part of MSBA Program

Somerville High School GSF	
LEVEL	AREA
SHOP LEVEL	50470 SF
RED PLANS	
1ST FLOOR	129100 SF
2ND FLOOR	90200 SF
3RD FLOOR	63710 SF
4TH FLOOR	55030 SF
TOTAL GSF	389520 SF

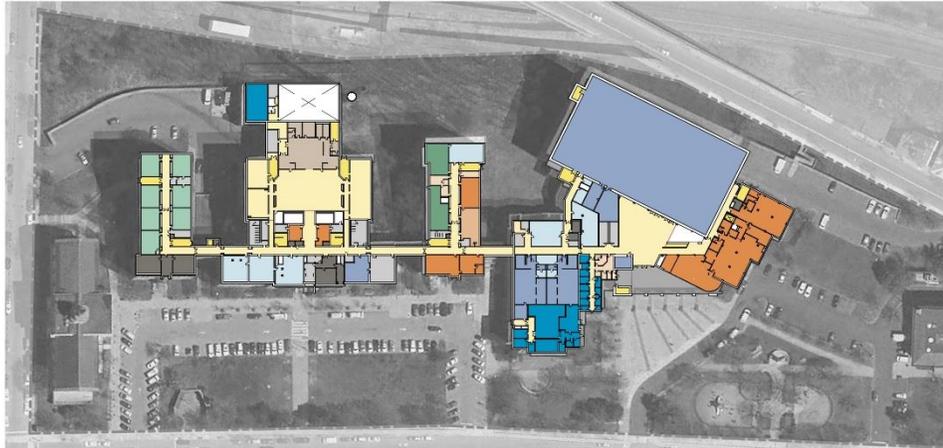
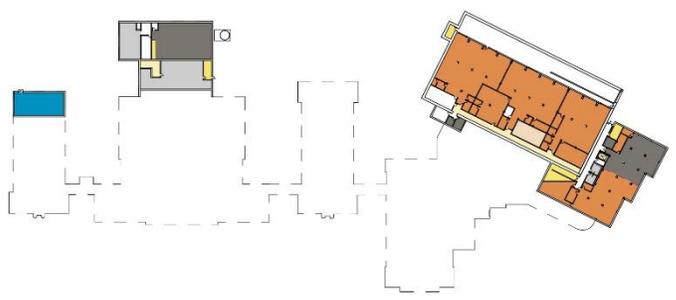
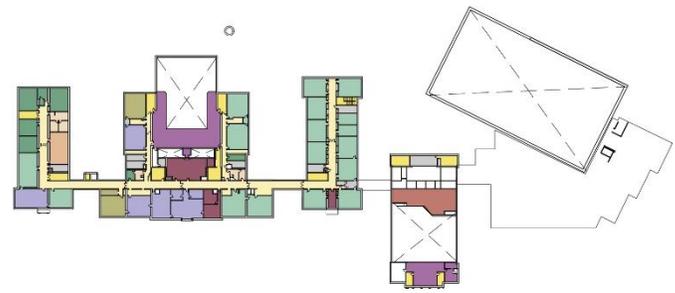
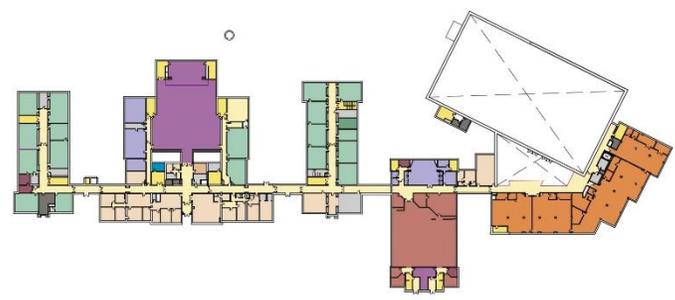
Ait 0 & 1

Alternative 0 – Code Upgrade & Repair Only

Alternative 1 – Full Gut Renovation, No New Additions

Both Alternatives Involve Phased Construction

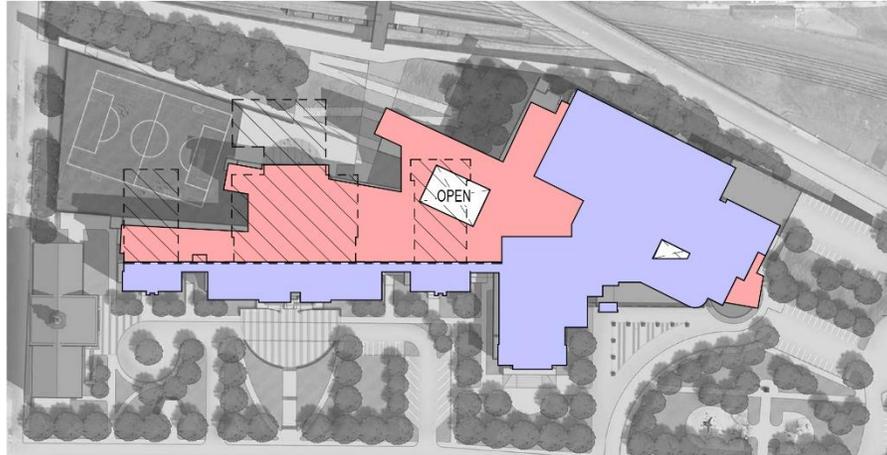
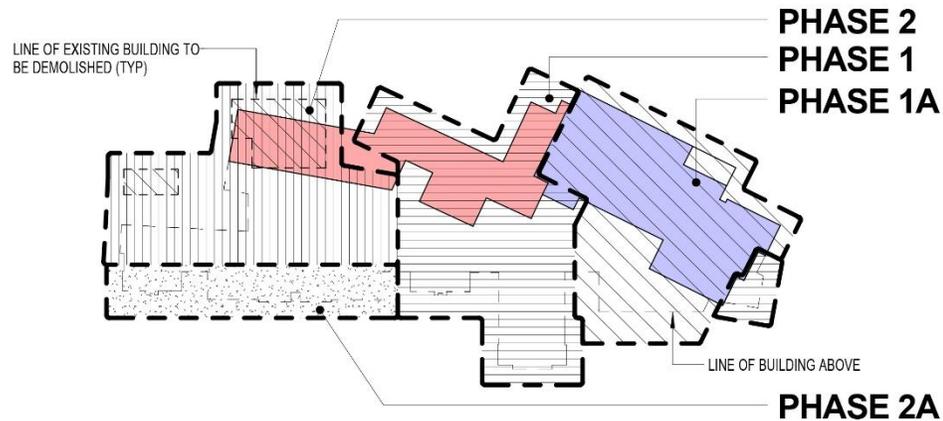
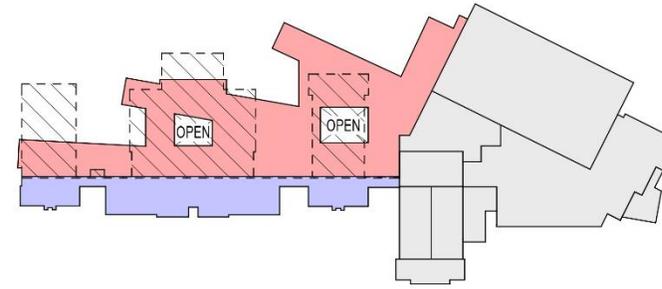
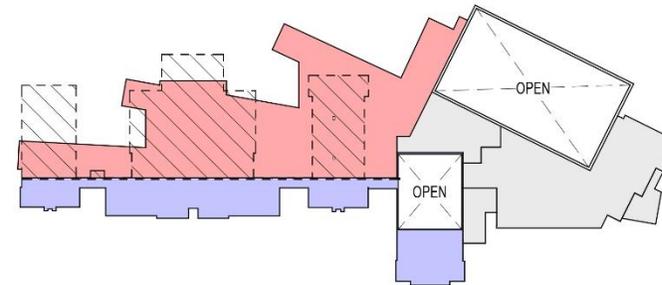
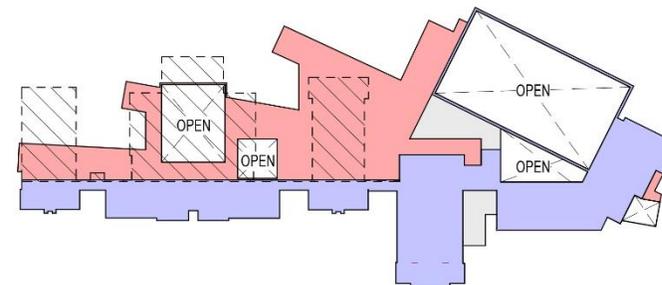
Ait 2

Alternative 2 – Addition /
Renovation

Renovate 1986 CTE
Wing & Southern
Portions of 1895/1929
Classrooms

New Auditorium &
Cafeteria

Phased Construction

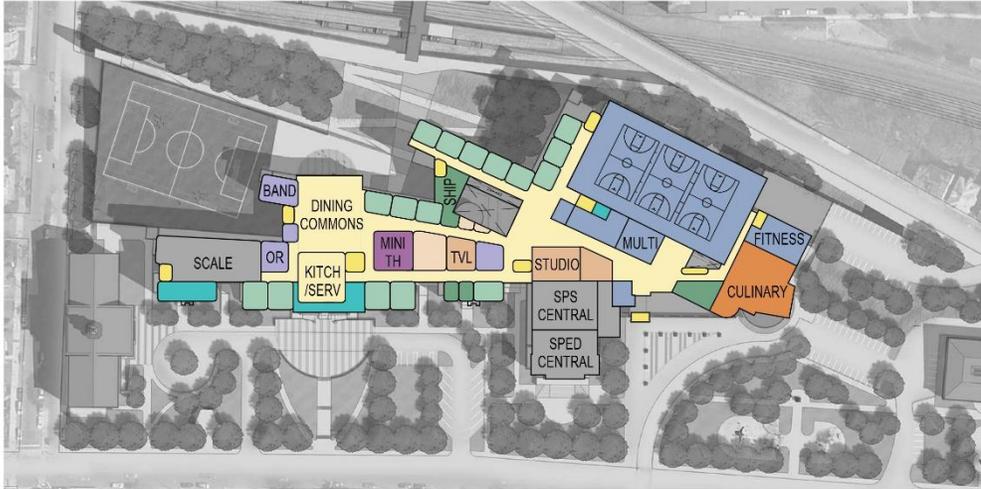
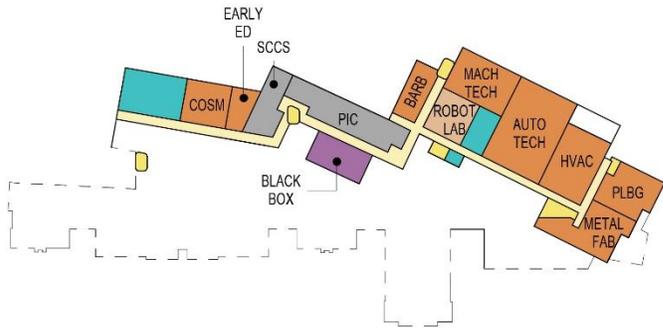
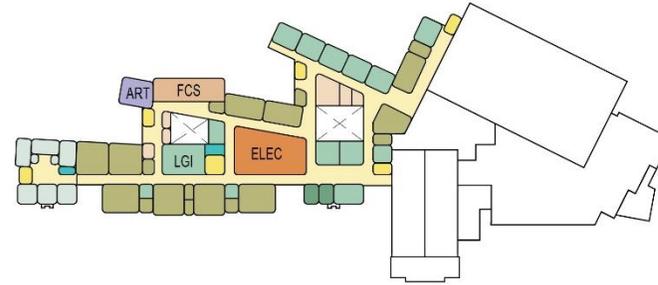
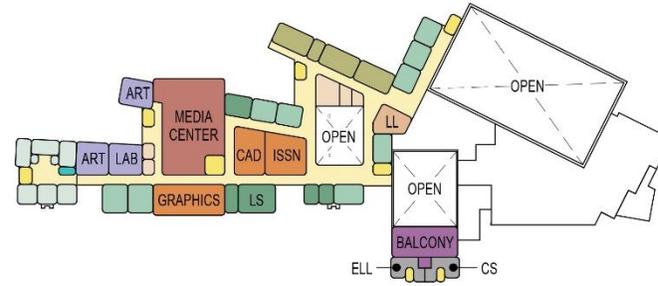
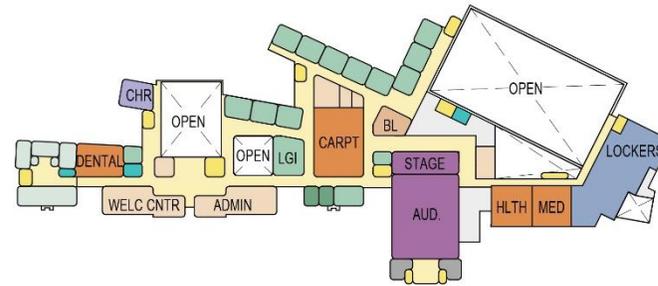
Alt 2

Alternative 2 – Addition / Renovation

Renovate 1986 CTE Wing & Southern Portions of 1895/1929 Classrooms

New Auditorium & Cafeteria

Phased Construction

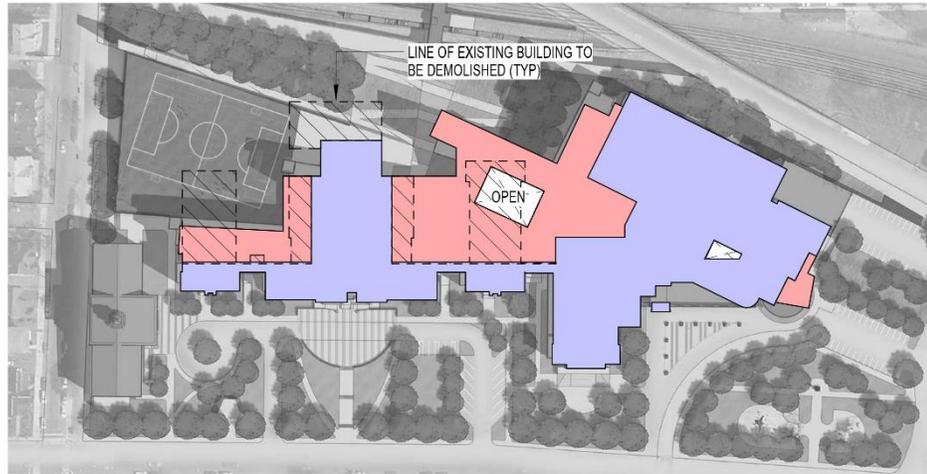
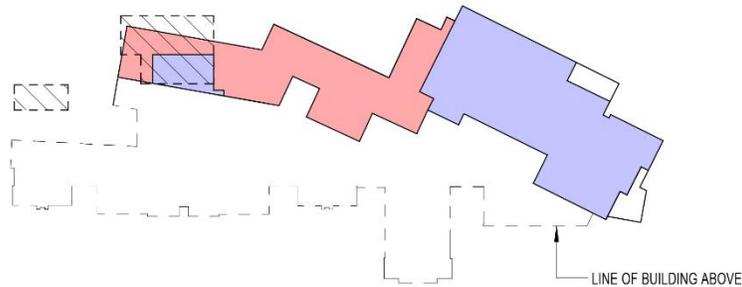
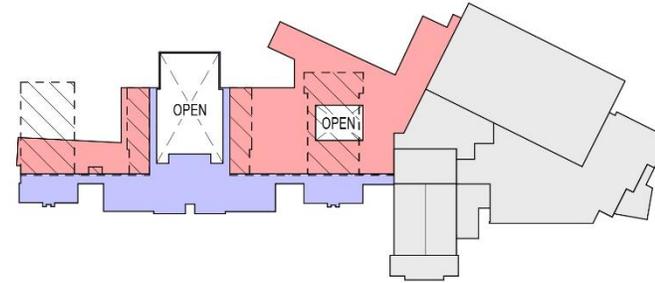
Ait 3

Alternative 3 – Addition / Renovation

Renovate 1986 CTE Wing & Southern Portions of 1895/1929 Classrooms

Renovate Auditorium

New Cafeteria

Phased Construction

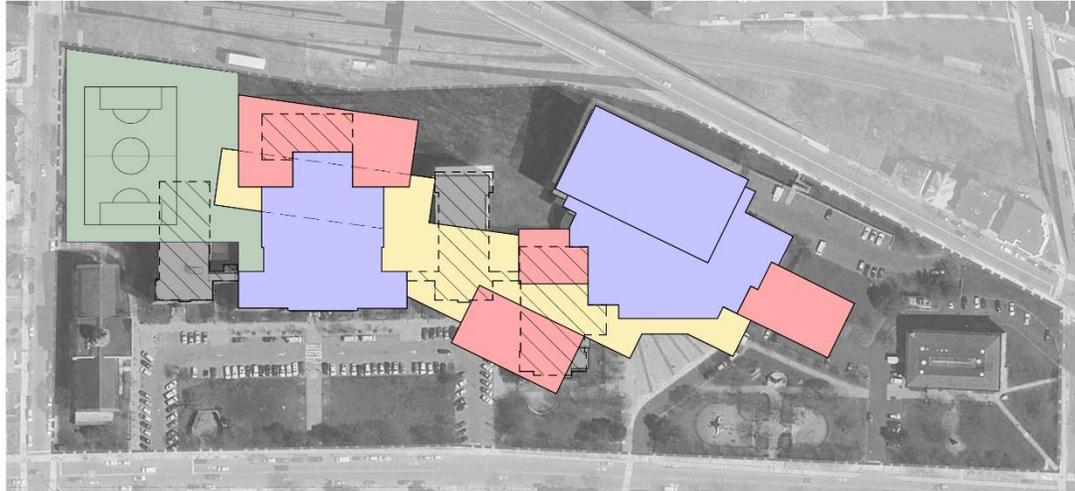
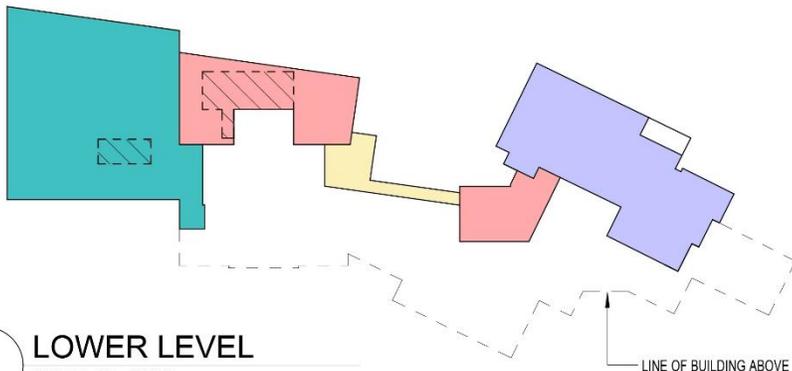
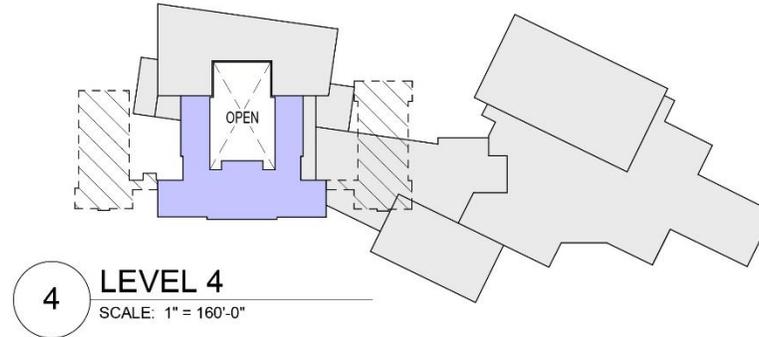
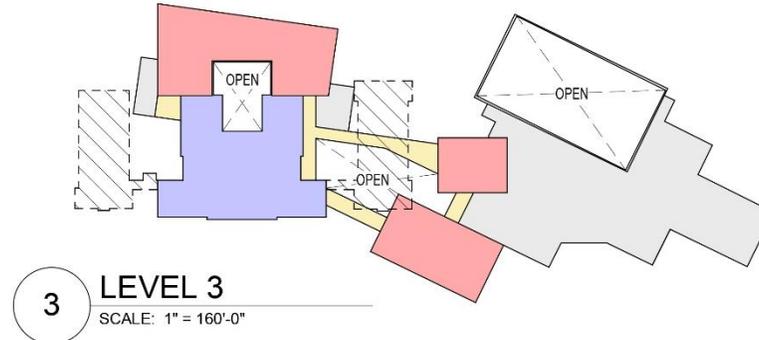
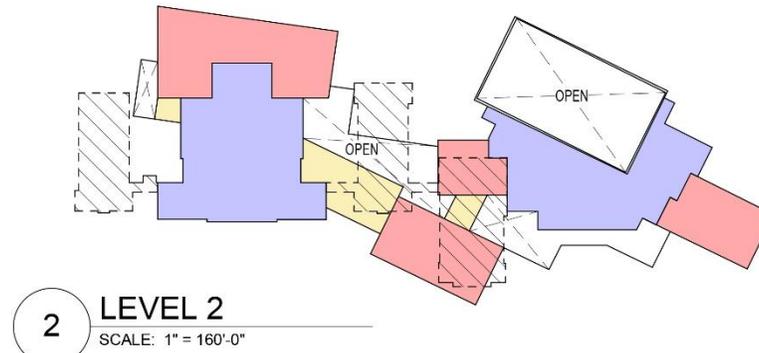
Ait 4

Alternative 4 – Addition / Renovation

Concourse Approach

Enclosed / Open Central Circulation and Activity Space – Incorporates Cafeteria

Renovate 1986 CTE Wing & 1895/1929 B Wing

Renovate Auditorium

Phased Construction

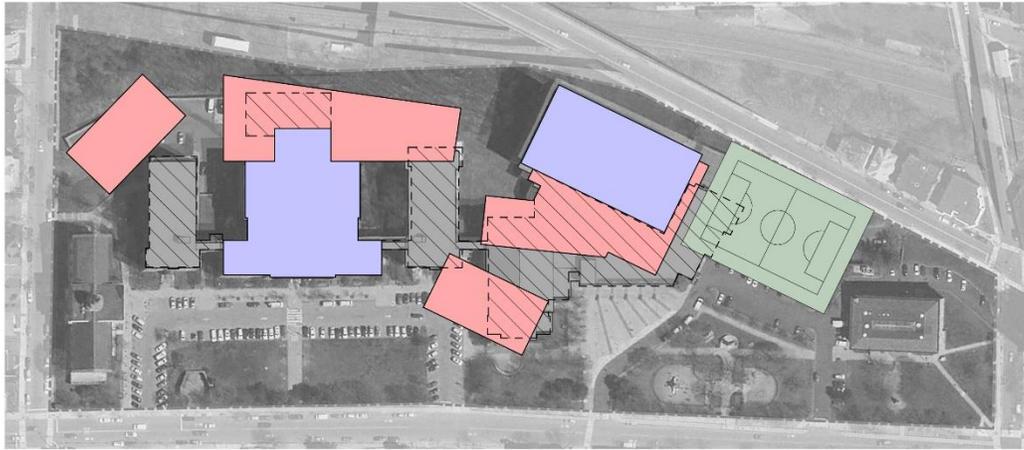
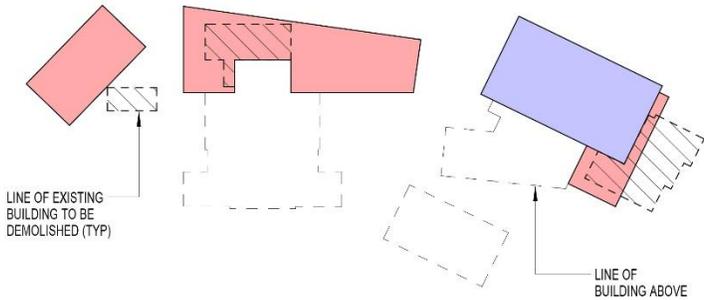
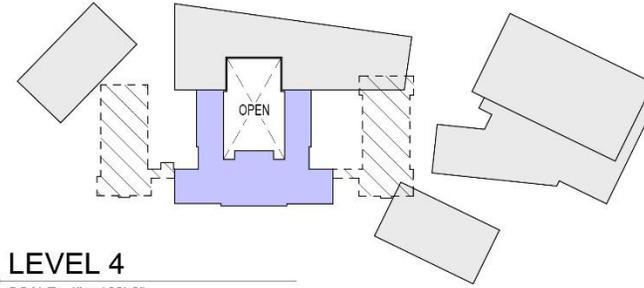
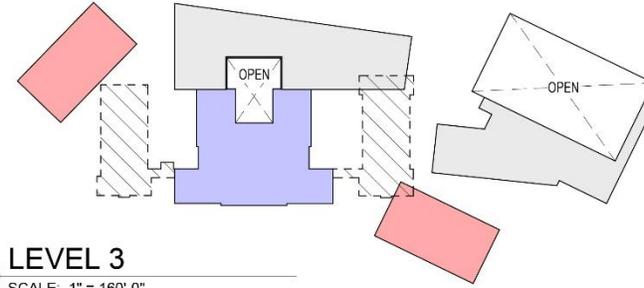
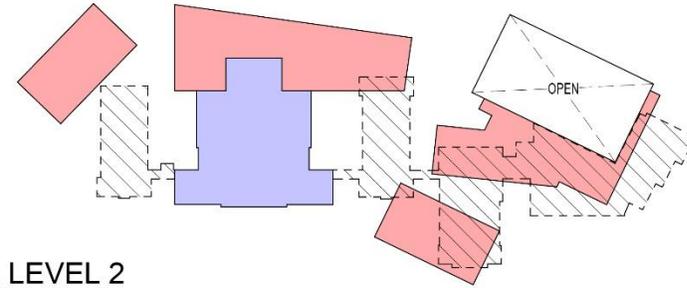
Alt 4a

Alternative 4a – Addition / Renovation

Campus Approach

Renovate 1986
Gymnasium & 1895
Building

Renovate Auditorium

New Cafeteria

New Disconnected
Buildings

Phased Construction

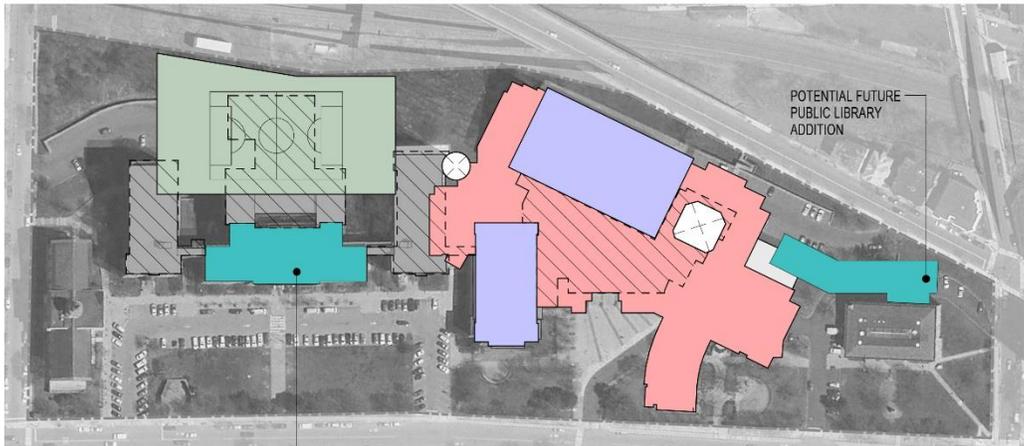
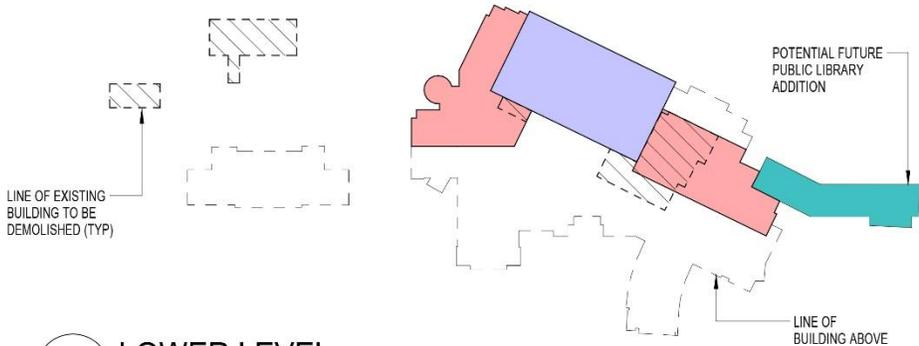
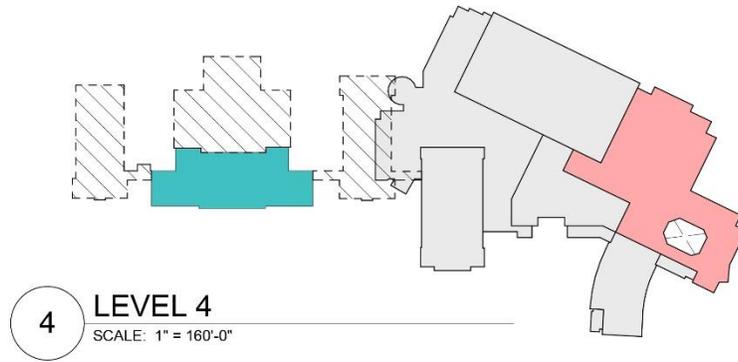
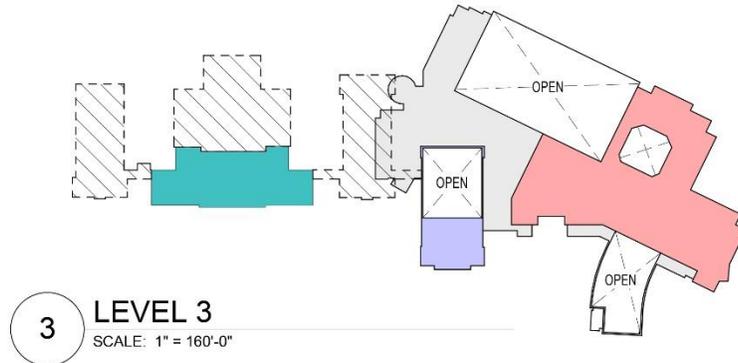
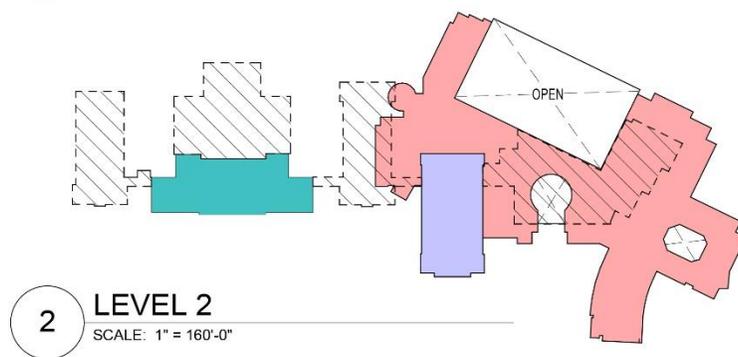
Alt 4b

POTENTIAL FUTURE RE-USE OF 1895 STRUCTURE FOR CITY OFFICES (TYP. FOR FOUR FLOORS)

Alternative 4b – Addition / Renovation

Build HS to East Site

Enclosed / Open Central Circulation and Activity Space – Incorporates Cafeteria

Renovate 1986 Field House & CTE Spaces below Wing & D Wing (1929 War Memorial)

Phased Construction

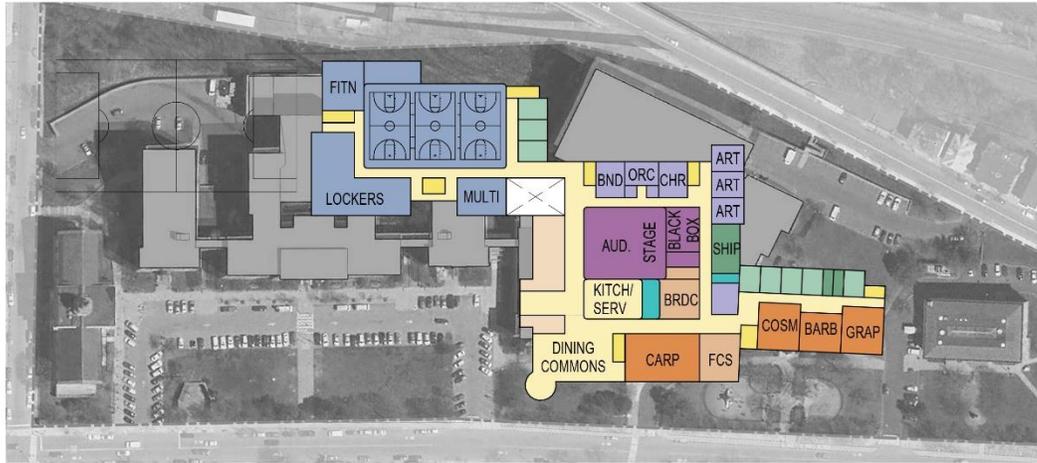
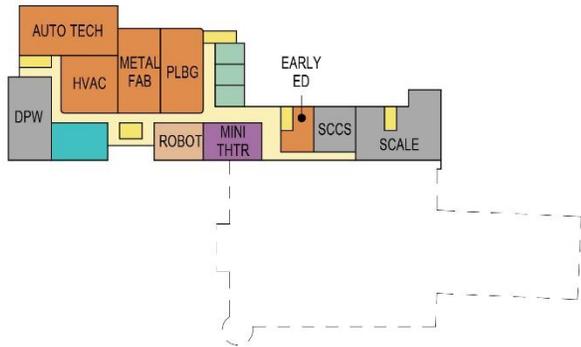
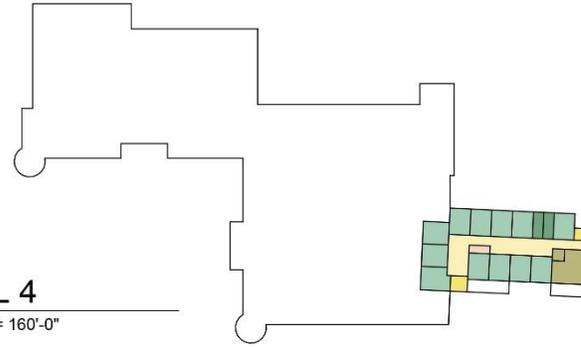
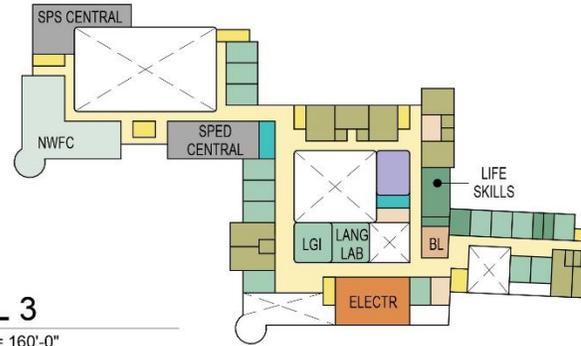
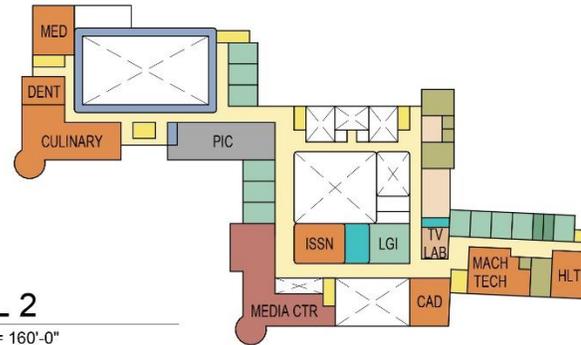
Ait 5

Alternative 5 – New Construction

Demolish Existing High School and Build Completely New on the Existing High School Site

Phased Construction

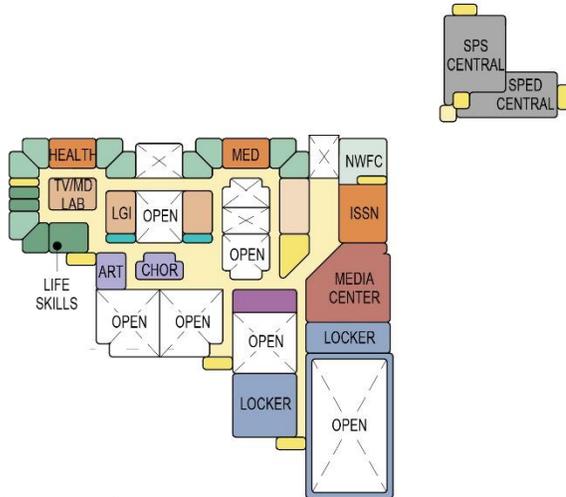
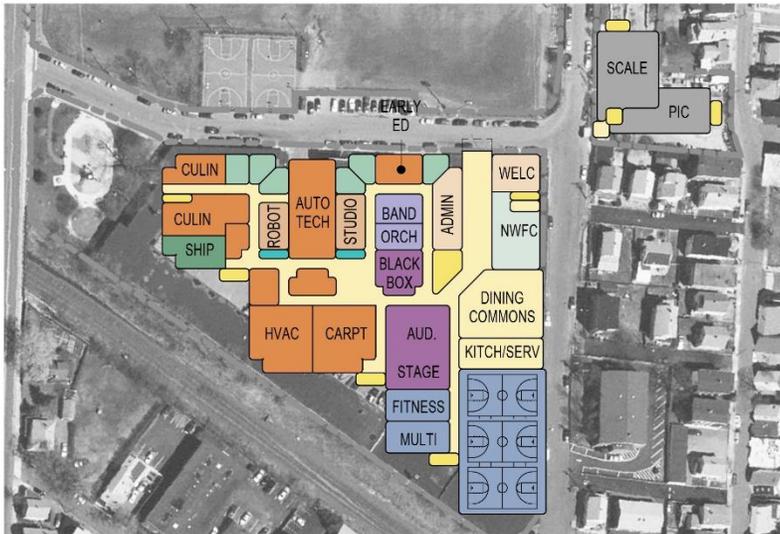
Ait 6

Alternative 6 – New Construction

Demolish DPW Structures and Build New at Franey Road Site
